INTERIM REPORT
TO CONGRESS

THE STREAMBANK EROSION CONTROL
EVALUATION AND DEMONSTRATION ACT OF 1974

September 1978

U. S. ARMY
CORPS OF ENGINEERS

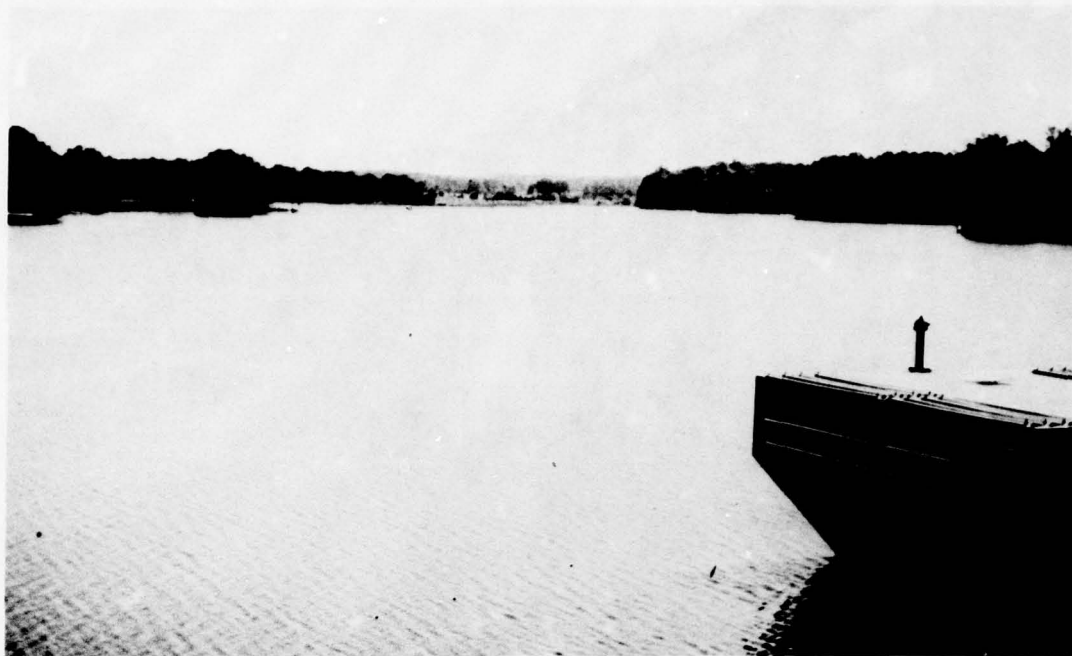
Photo 1. Soil Conservation Service flood control structure

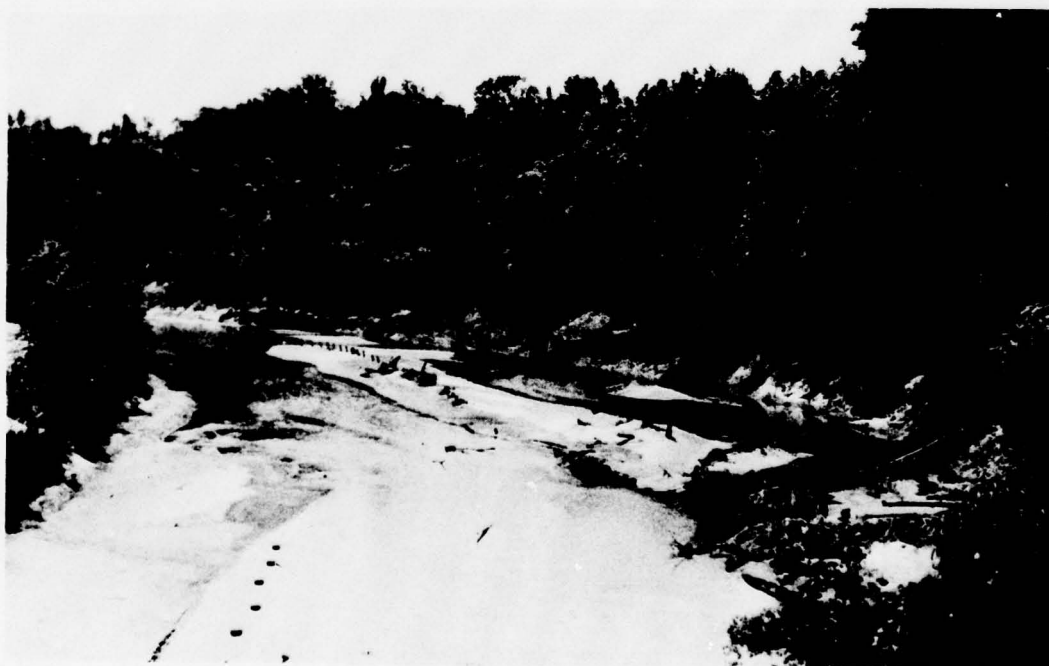
4. The first protection method observed on Big Sand Creek was a system of board fencing parallel to the streambank on the outside bank of a channel bend with concrete jacks upstream and downstream of the fencing (Photos 2 and 3). Fencing and jacks have been used in several locations on the Big Sand Creek and have worked well for the 10 years they have been in place. The next area observed on the Big Sand was where kudzu had been planted to stabilize the bank (Photo 4). The kudzu was not doing an adequate job of stabilizing the bank and had taken over the overbank vegetation.

Photo 4. Kudzu on outside bank of bend

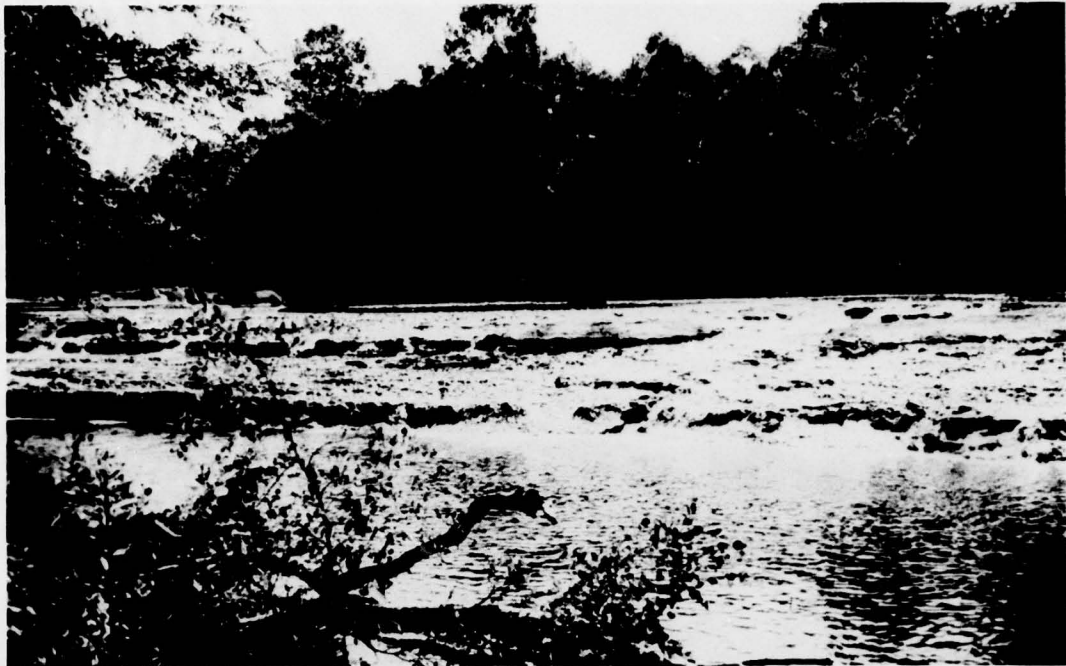
5. In the upper reaches of the Big Sand Creek, an outcropping of a clay-sand mixture forms a natural grade control structure (Photo 5). If the Big Sand were to cut through this natural control, additional degradation and subsequent bank erosion would most likely occur upstream of the outcropping.

Photo 5. Natural grade control

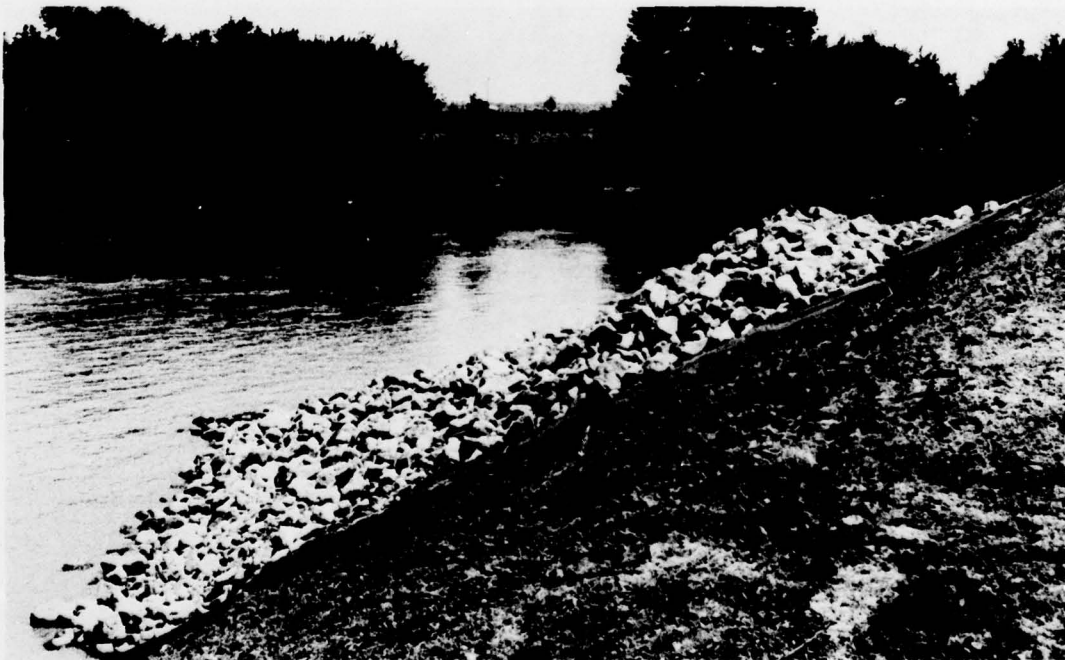
7. Next, riprap revetment was observed at the junction of the Greenwood diversion canal and the Tallahatchie River (Photo 8). The riprap was being placed on a 1V-on-2H slope on a black plastic filter cloth. Toe protection for the revetment was being extended well out into the river.

Photo 8. Riprap placement on black plastic filter material

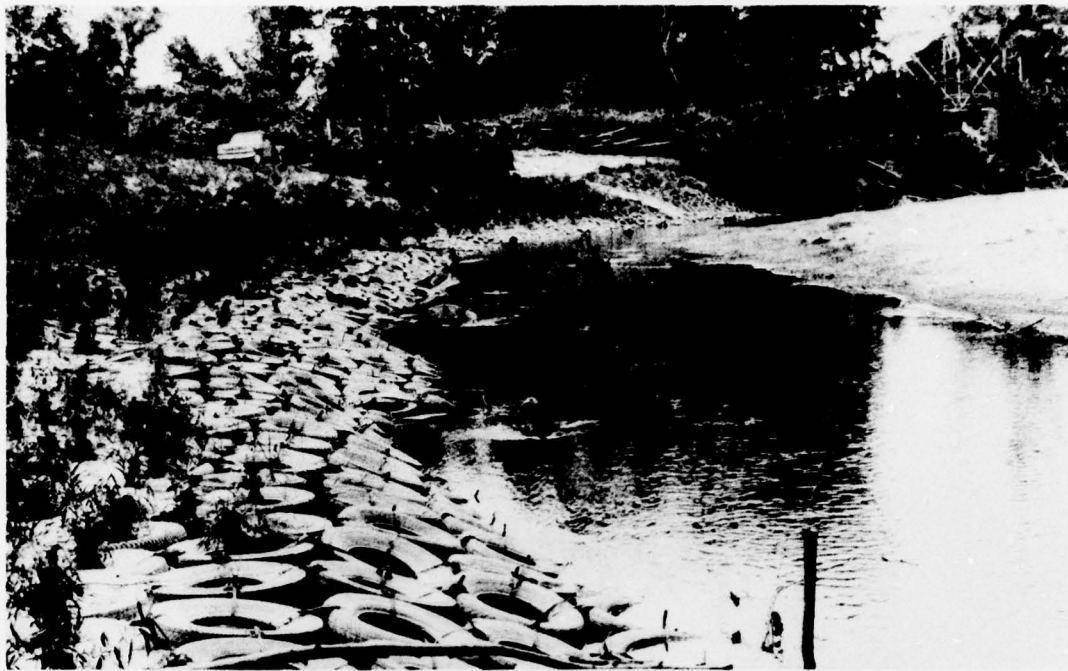
8. The inspection continued to Tillatoba Creek near Charleston, Mississippi, where the Vicksburg District has a very active bank protection program under way. Many of the Section 32 demonstration sites are located on Tillatoba Creek. The first area observed was a mattress of tires connected together with steel bands around the periphery and anchored with cables attached to guy wire anchors (Photos 9 and 10). Willow shoots were planted in the tires and about 50 percent were growing.

Photo 9. Tire mattress

Photo 10. Tire mattress with willow shoots
planted to increase stability

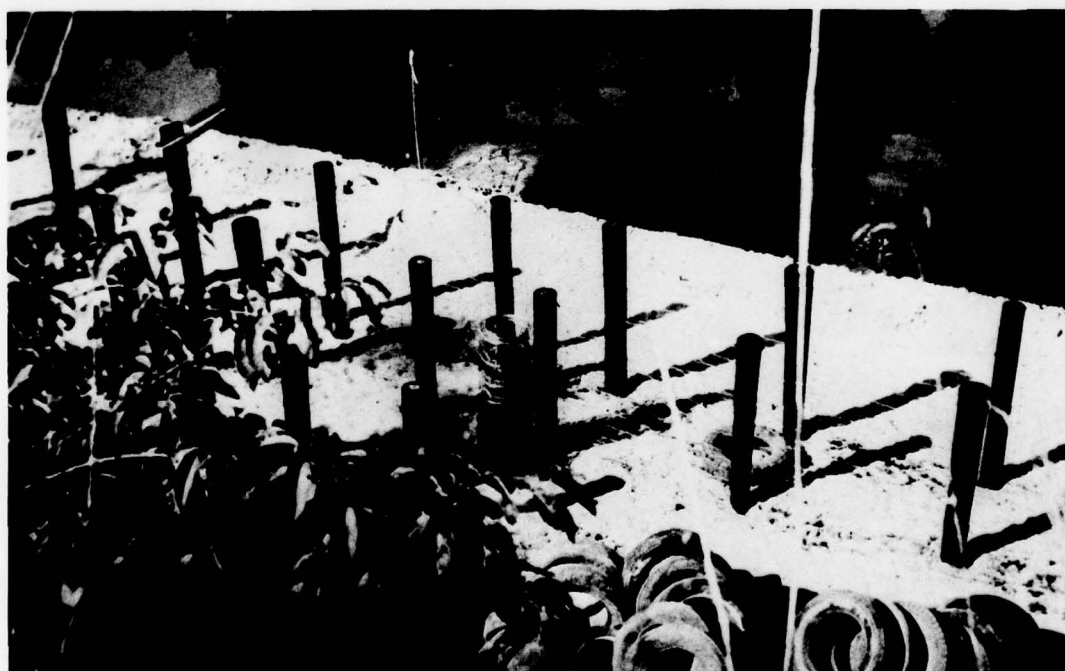
Photo 12. Double-row wire fence (to be filled with tires)

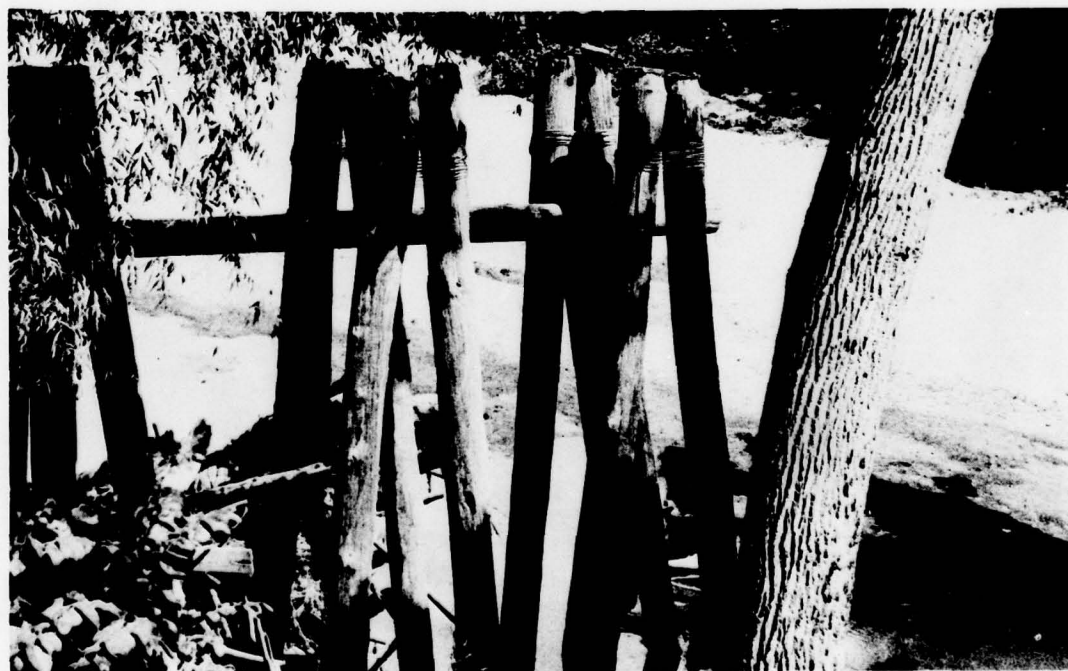
10. Timber pile groins that had been in place many years were observed in a bend upstream of the highway bridge (Photo 14). These groins had trapped debris and appeared effective in halting the erosion of the outside bank of the bend. Riprap hard points were observed at two locations on Tillatoba Creek (Photos 15 and 16). Kudzu was well established between the riprap hard points at one location.

Photo 14. Timber pile groins

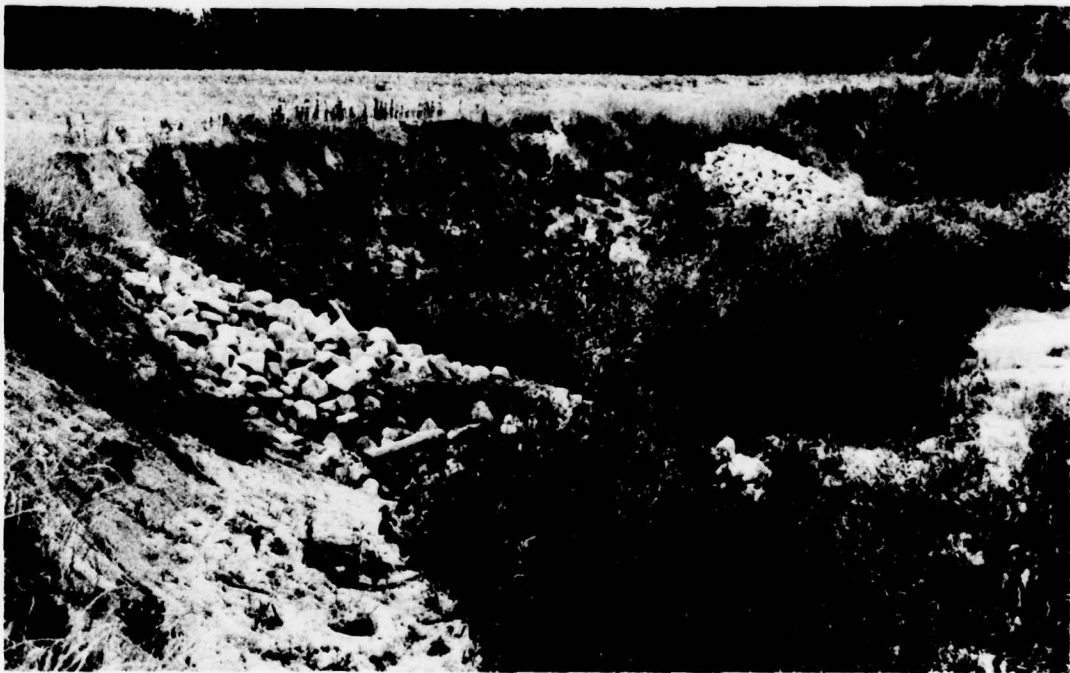
Photo 16. Riprap hard points

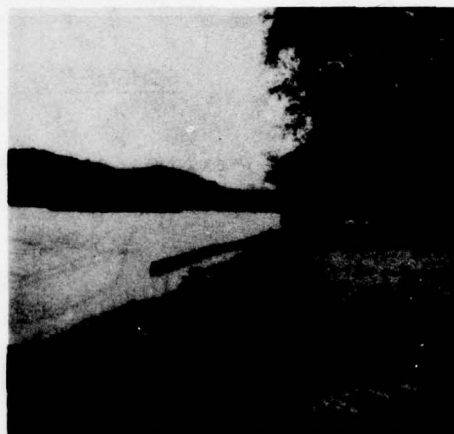
Status. Construction of the major components of the protection works was completed in late summer 1977. Observations to date indicate that overland flow from the bank is causing gullyng within upper bank areas. The elevation of the breakwater fence is not high enough and wave washing at frequently encountered pools is causing problems (Plate E15). Additionally, the protection of the Longard tube with an acceptable epoxy coating is an outstanding work item.

UPSTREAM VIEW OF
RAVENSWOOD, W. VA.
DEMONSTRATION SITE

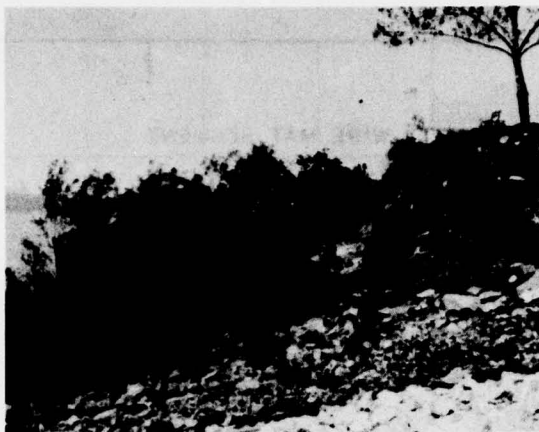
CAVING BANK AT WATER WORKS
FROM UPSTREAM. BANK IS ABOUT
30 FT HIGH AND CHANNEL IS
ABOUT 1900 FT. FEBRUARY 1974

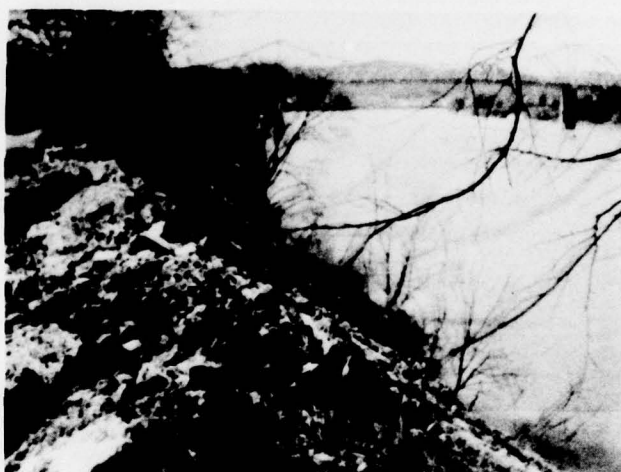
DEMONSTRATION SITE, 23 MARCH 1977

DEMONSTRATION SITE
LOOKING DOWNSTREAM
KANAWHA RIVER,
SOUTH CHARLESTON, WEST VIRGINIA

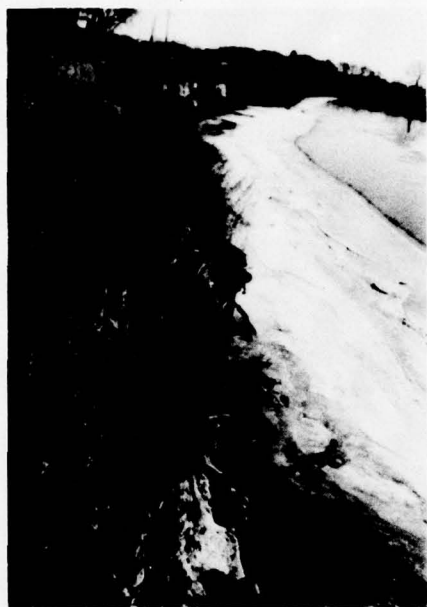
**BANK LINE BEFORE PROTECTION,
FEBRUARY 1977**

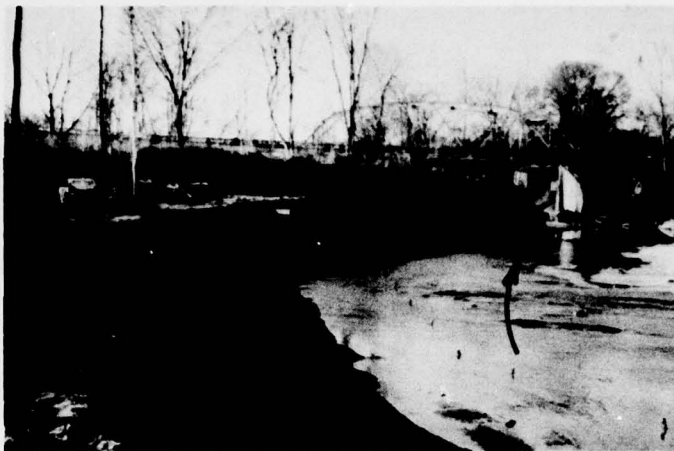
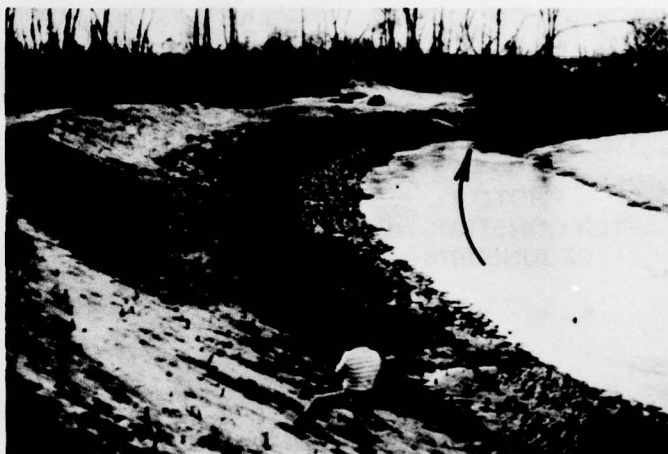
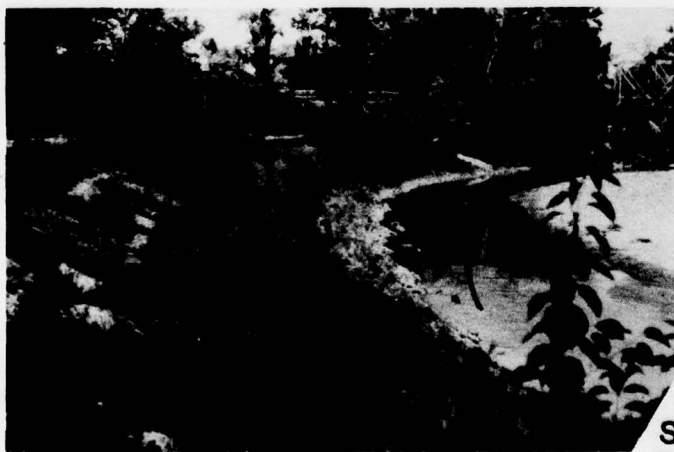
TILLATOBA CREEK,
NORTH FORK, ITEM 1
LONGITUDINAL DIKE WITH
BANK GRADING AND VEGETATION
18-FT-HIGH BANK

Status. Contractor had problems during construction, mostly due to lack of experience. An undersized riprap was placed below the weir and a large overbank drain just upstream on left bank had inadequate protection. Several large flows were experienced during construction and one extremely high flow after construction in November 1977. The only damage to the structure was loss of top bank which had improper time for vegetation germination.
